**Division of Fire Safety**  
**Office of the State Fire Marshal**  
J. William Degnan, State Fire Marshal

## **TECHNICAL BULLETIN AND POLICY**

### **Installation of Wiring Methods Below Roof Decks**

December 28, 2005

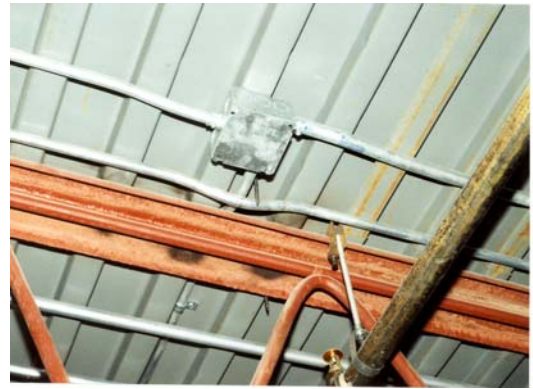
1. The area in question is located just below a steel roof deck. In this case it included the voids in the roof deck material. In this picture you can see the screws used to secure the roofing material that just missed the box and raceway.

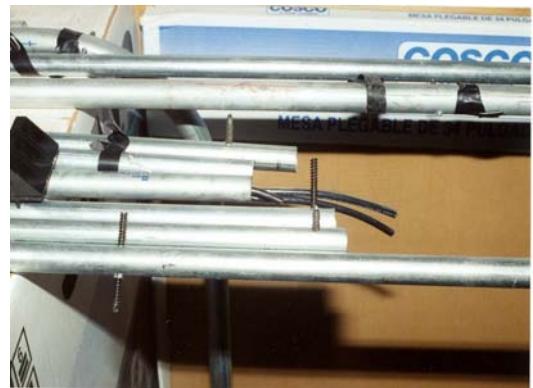
2. There were several raceways that were secured in the area just below the roof deck and the top of the framing members that had been penetrated by the screws used to secure the roofing material.

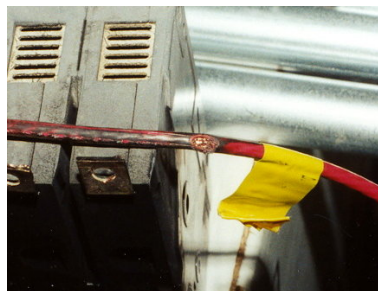
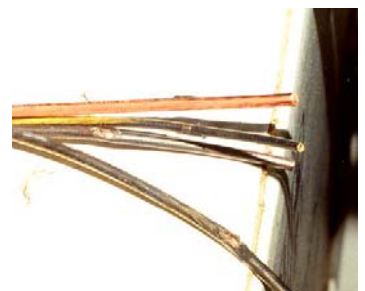
3. Where the screws penetrated the raceways they also penetrated some of the conductors which caused the circuit breakers to trip.

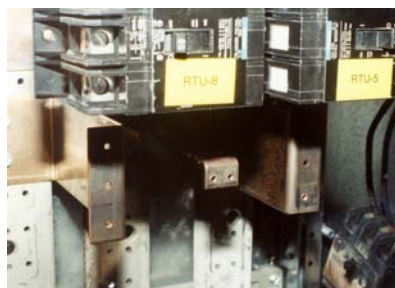
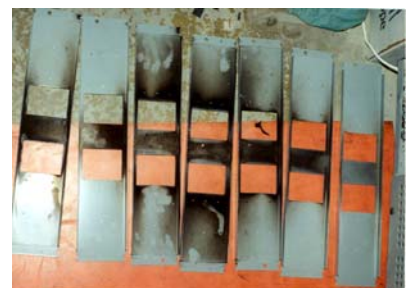
4. There appears to have been arcing between phases and/or between phases and ground, as indicated by the significant amount of carbon, which took out the main fuses before any major damage occurred.

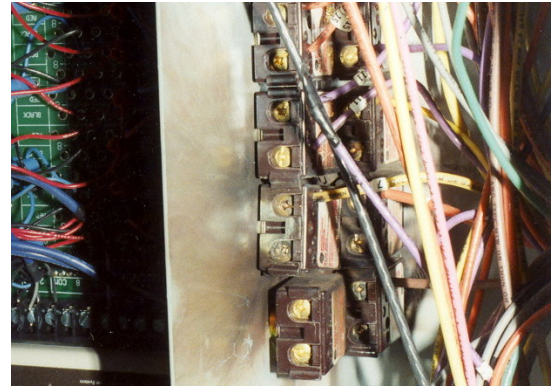
5. There was also evidence of arcing occurring around some of the relays used in the lighting control panel.
